Structural Reinforcement of the STS Panamax Container Cranes

Technical Description of the Scope of Works

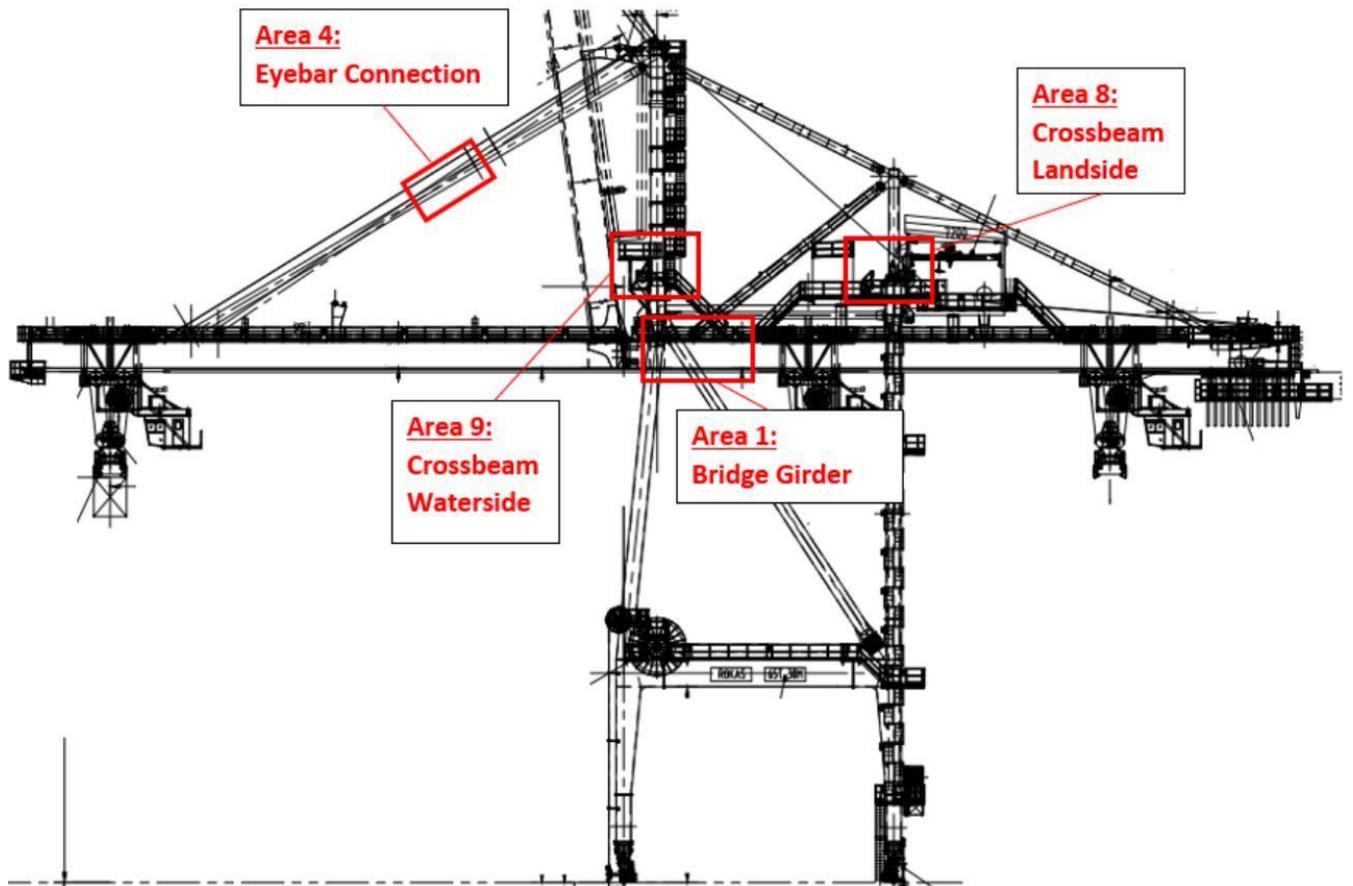
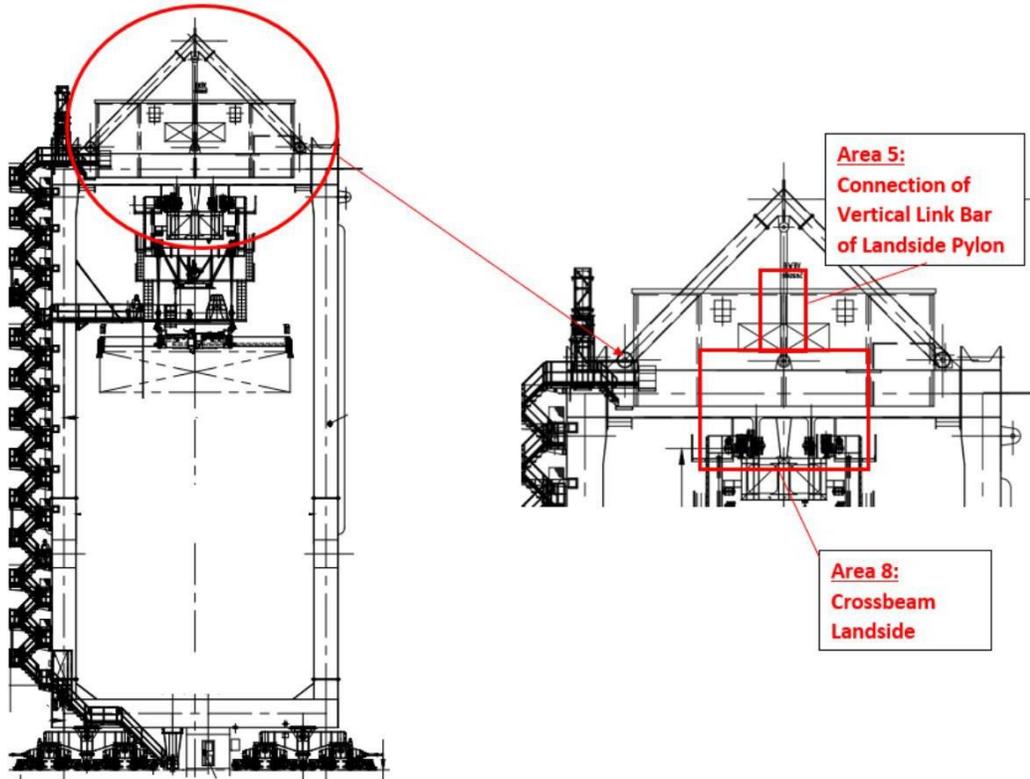
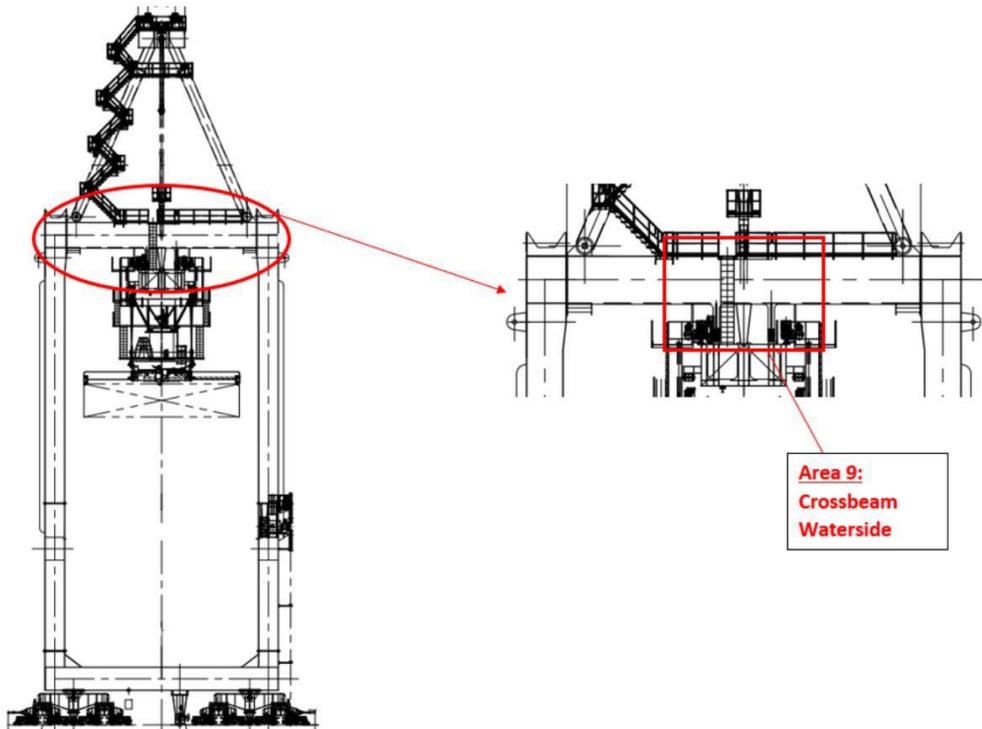
The below figures represent the structural areas/items of the STS Container Cranes - Main structure, which need to be reinforced.

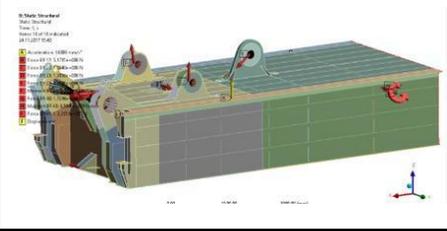
| Area / Item No | Description | Action | Remarks | Area Detail |
|---|---|---|---|---|
| 1 | Bridge girder connection to Backstay 2 (Ref. 2) | <ul style="list-style-type: none"> a. Yield Check b. Fatigue Check c. Calculation Report d. Structural Drawings of the Proposed Reinforcements e. Repair Procedures Report | N/A | |

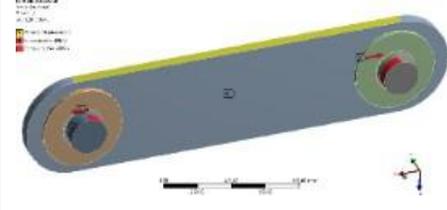
| Area / Item No | Description | Action | Remarks | Area Detail |
|---|---|---|---|---|
| 4 | Eyebar connection of link bar of forestay (Ref. 2) | <ul style="list-style-type: none"> a. Yield Check b. Calculation Report c. Structural Drawings of the Proposed Reinforcements d. Repair Procedures Report | N/A | |

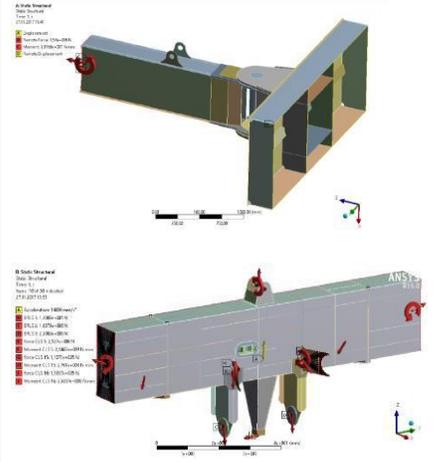
| Area / Item No | Description | Action | Remarks | Area Detail |
|---|---|---|---|---|
| 5 & 8 | Connection of vertical link bar of landside pylon to Crossbeam & Crossbeam landside (Ref. 2) | <ul style="list-style-type: none"> a. Yield Check b. Fatigue Check c. Calculation Report d. Structural Drawings of the Proposed Reinforcements e. Repair Procedures Report | N/A | |

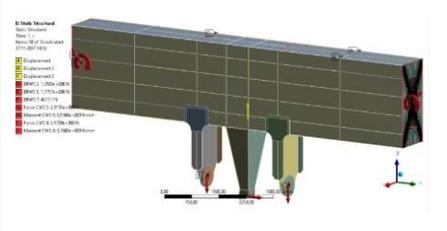
| Area / Item No | Description | Action | Remarks | Area Detail |
|---|---|---|---|---|
| 9 | Crossbeam waterside (Ref. 2) | <ul style="list-style-type: none"> a. Yield Check b. Fatigue Check c. Calculation Report d. Structural Drawings of the Proposed Reinforcements e. Repair Procedures Report | N/A | |

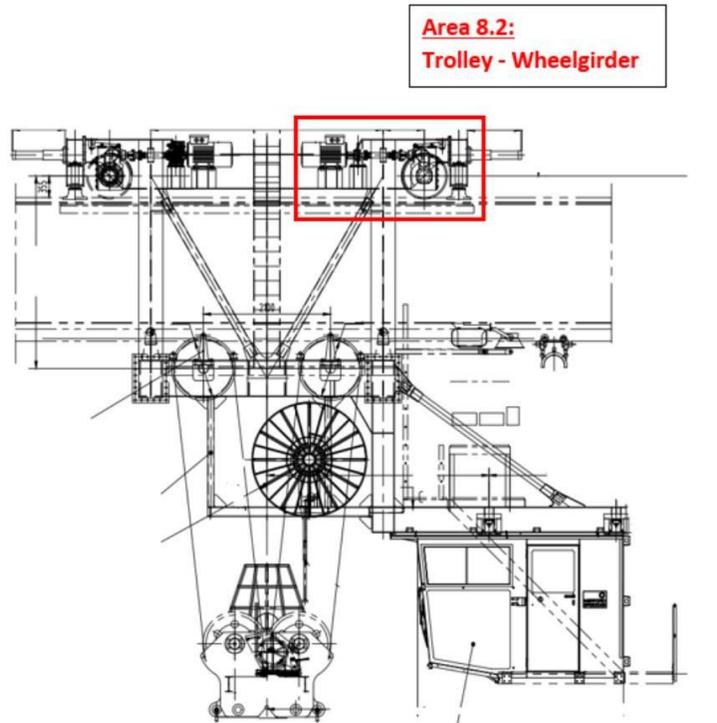
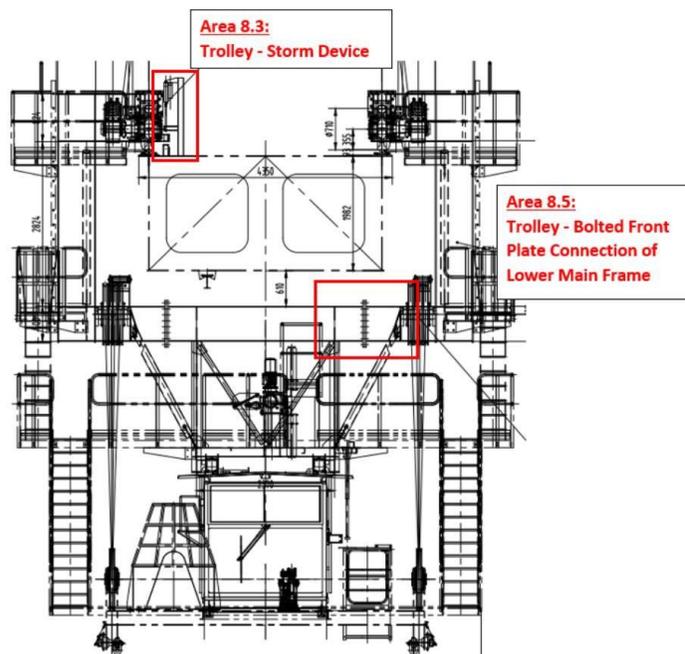
The below figures represent the structural items of the Trolley structure of the STS Panamax Container Cranes, which need to be reinforced.

| Area / Item No | Description | Action | Remarks | Area Detail |
|---|---|---|---|---|
| 10 | Trolley Model (Ref. 3) | <ul style="list-style-type: none"> a. Reduction of the Transverse Deflection of the vertical trolley beams b. Calculation Report c. Structural Drawings of the Proposed Reinforcements d. Repair Procedures | N/A | |
| 8.2 | Wheel Girder (Ref. 3) | <ul style="list-style-type: none"> a. Yield Check b. Fatigue Check c. Calculation Report d. Structural Drawings of the Proposed Reinforcements e. Repair Procedures Report | N/A | |
| 8.5 | Bolted Front Plate Connection of Lower Main Frame (Ref. 3) | <ul style="list-style-type: none"> a. Yield Check b. Fatigue Check c. Calculation Report d. Structural Drawings of the Proposed Reinforcements e. Repair Procedures Report | N/A | |
| 8.3 | Storm Anchor Device (Ref. 3) | <ul style="list-style-type: none"> a. Yield Check b. Calculation Report c. Structural Drawings of the Proposed Reinforcements d. Repair Procedures Report | N/A | |

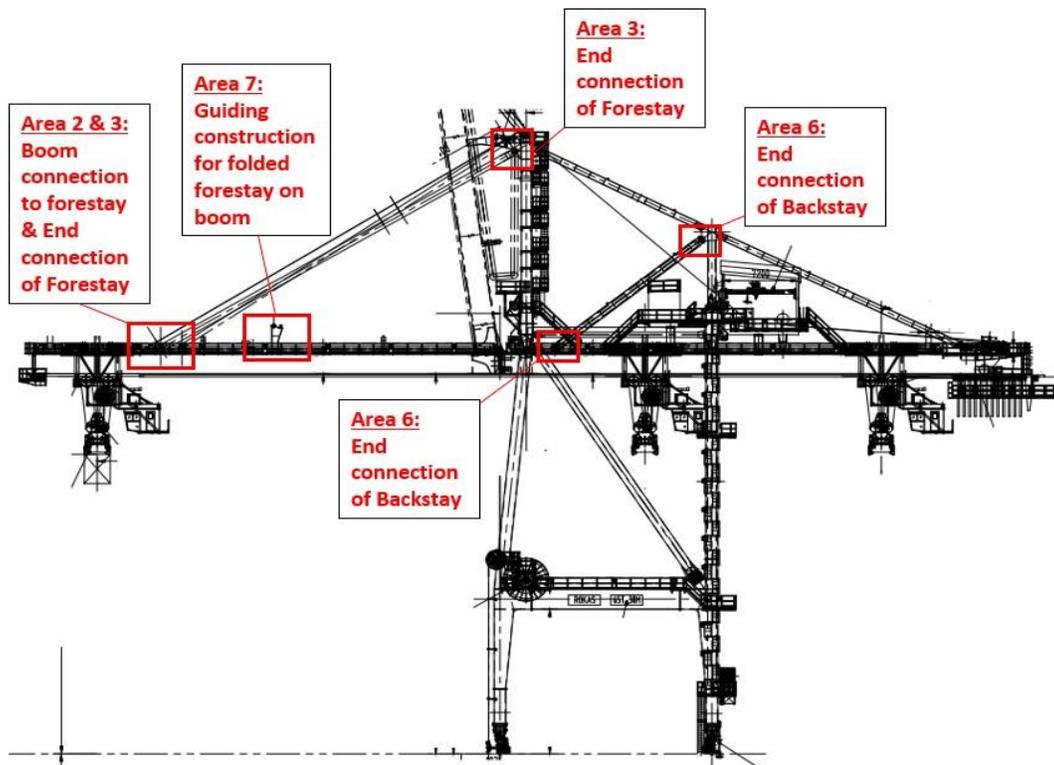
The below figures represent the structural areas of the STS Container Cranes, for which local structural improvement is requested.

Based on the preliminary calculation report (Ref. 2), no structural reinforcement is required for items 2, 3, 6 and 7.

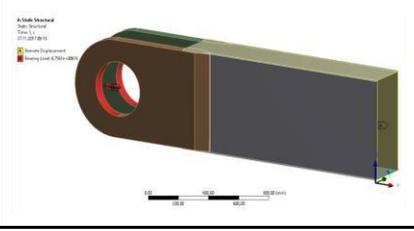
| Area / Item No | Description | Action | Area Detail |
|---|---|---|---|
| 3 | End connection of Forestay 1 (Ref. 2) | a. Repair Procedures Report b. Structural Drawings | |

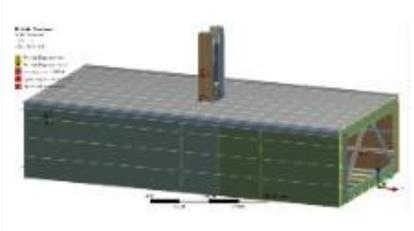
| Area / Item No | Description | Action | Area Detail |
|---|---|---|---|
| 7 | Guiding construction for folded forestay on boom (Ref. 2) | a. Repair Procedures Report b. Structural Drawings | |

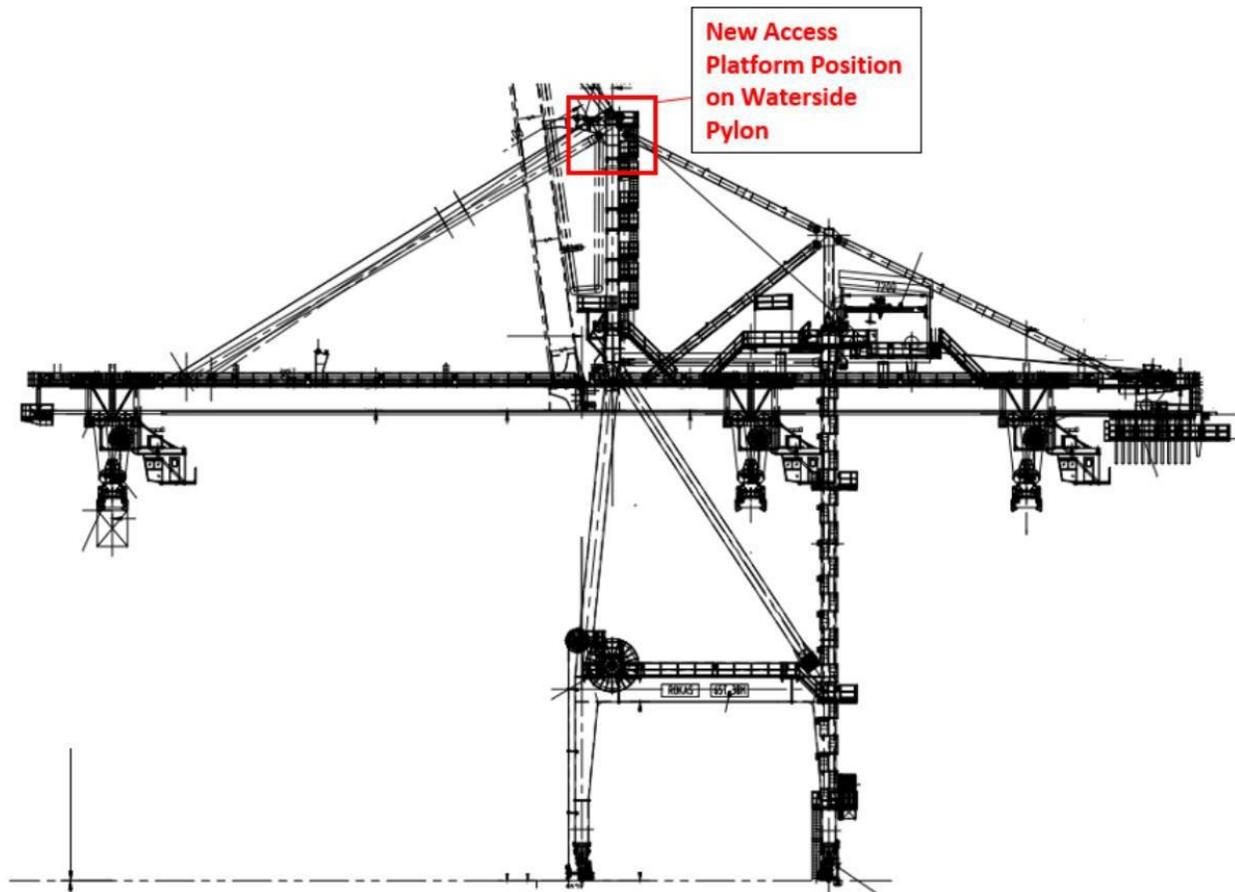
A new Access Platform is requested to be designed and installed on top of the Waterside Pylon. The position of the new Access Platform is presented in the following figure.

- An Access Platform will be designed and installed on top of the “Waterside Pylon” of the main crane structure. For more details, please refer to chapter 3.3.

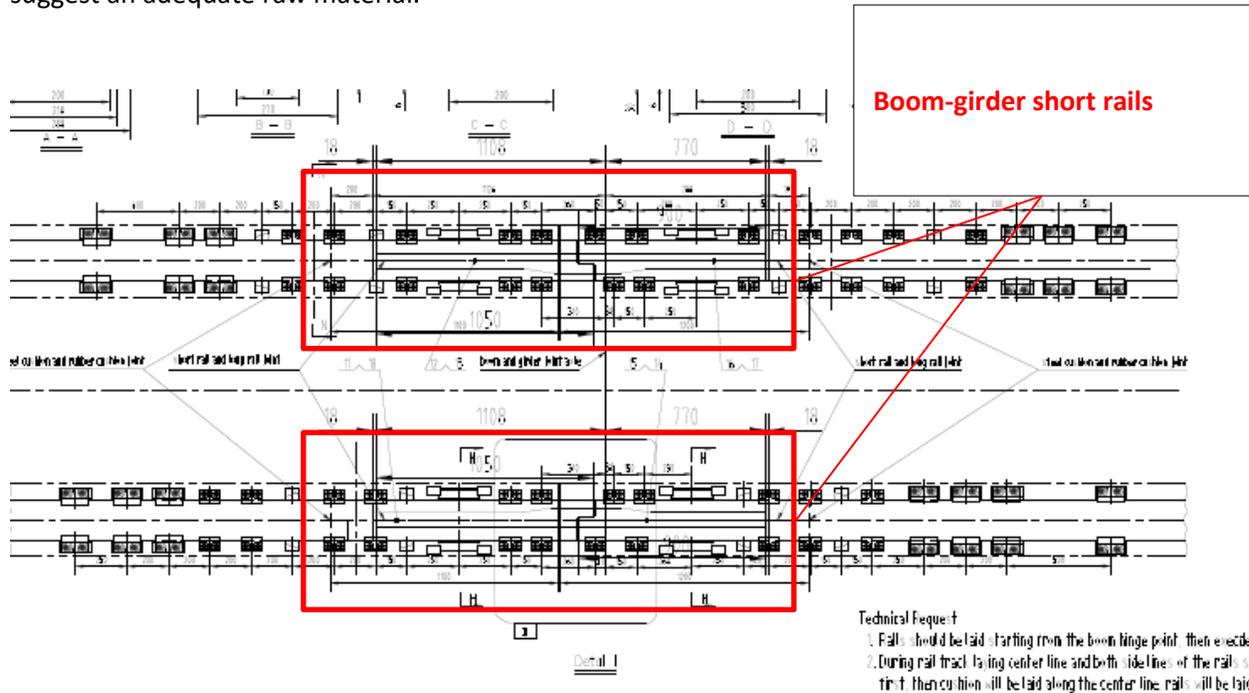
At Boom-girder short rails, the type, quantity and location of the clamps should be redesigned and to suggest an adequate raw material.

- At Boom-girder short rails, the type, quantity and location of the clamps should be redesigned and to suggest an adequate raw material for the short rails, please refer to chapter 3.4.

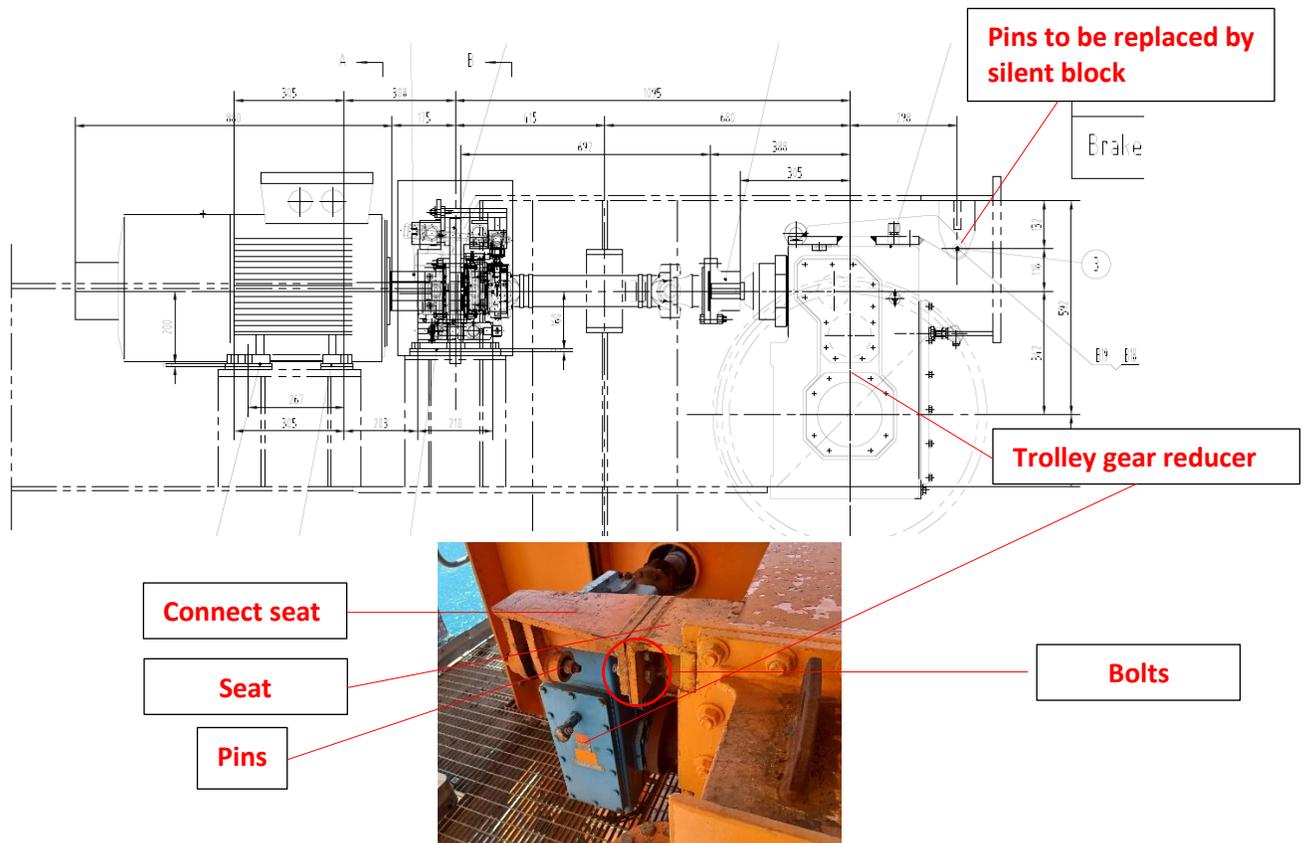
Replacement of the four (4) pins that fixed the “Connect seat” at the Trolley with appropriate silent blocks. Also, a check should be performed on the bolts that connect the “Seat” with the “Connect Seat” due to often failures of the bolts.

- Replacement of the four (4) pins that fixed the “Connect seat” at the Trolley with appropriate silent blocks. Also, a check should be performed on the bolts that connect the “Seat” with the “Connect Seat” due to often failures of the bolts please refer to chapter 3.5.

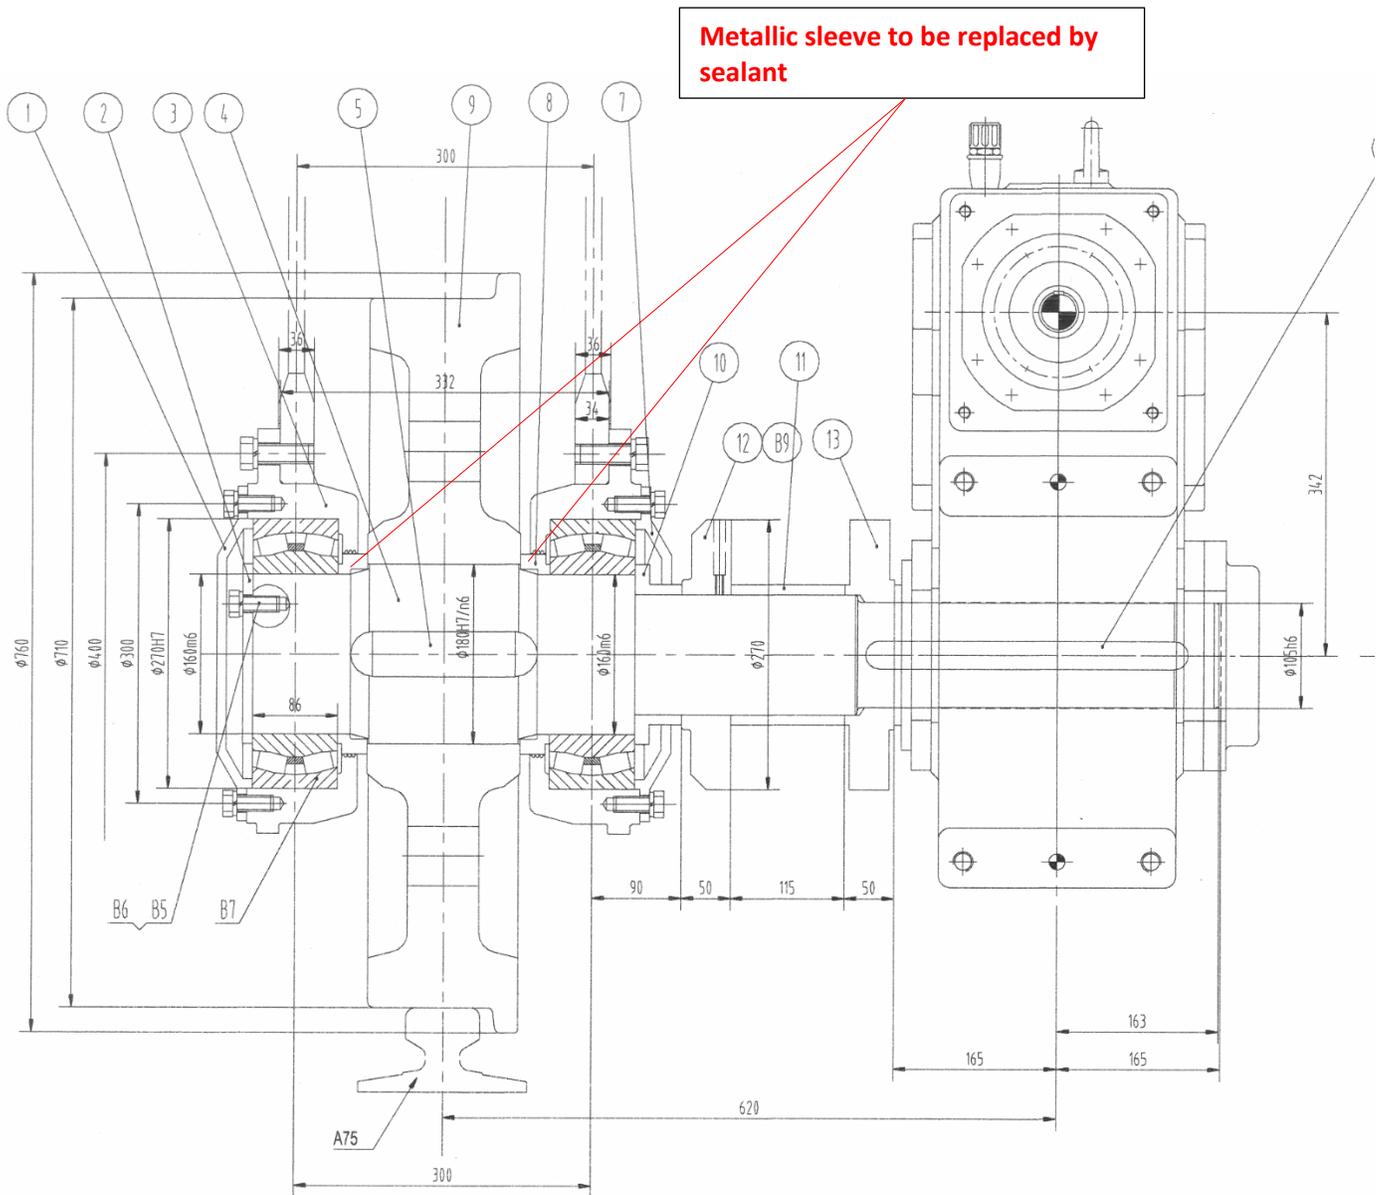
Replacement, at the Trolley shafts, of the metallic Sleeve with a sealant. Modification on the axles may be required.

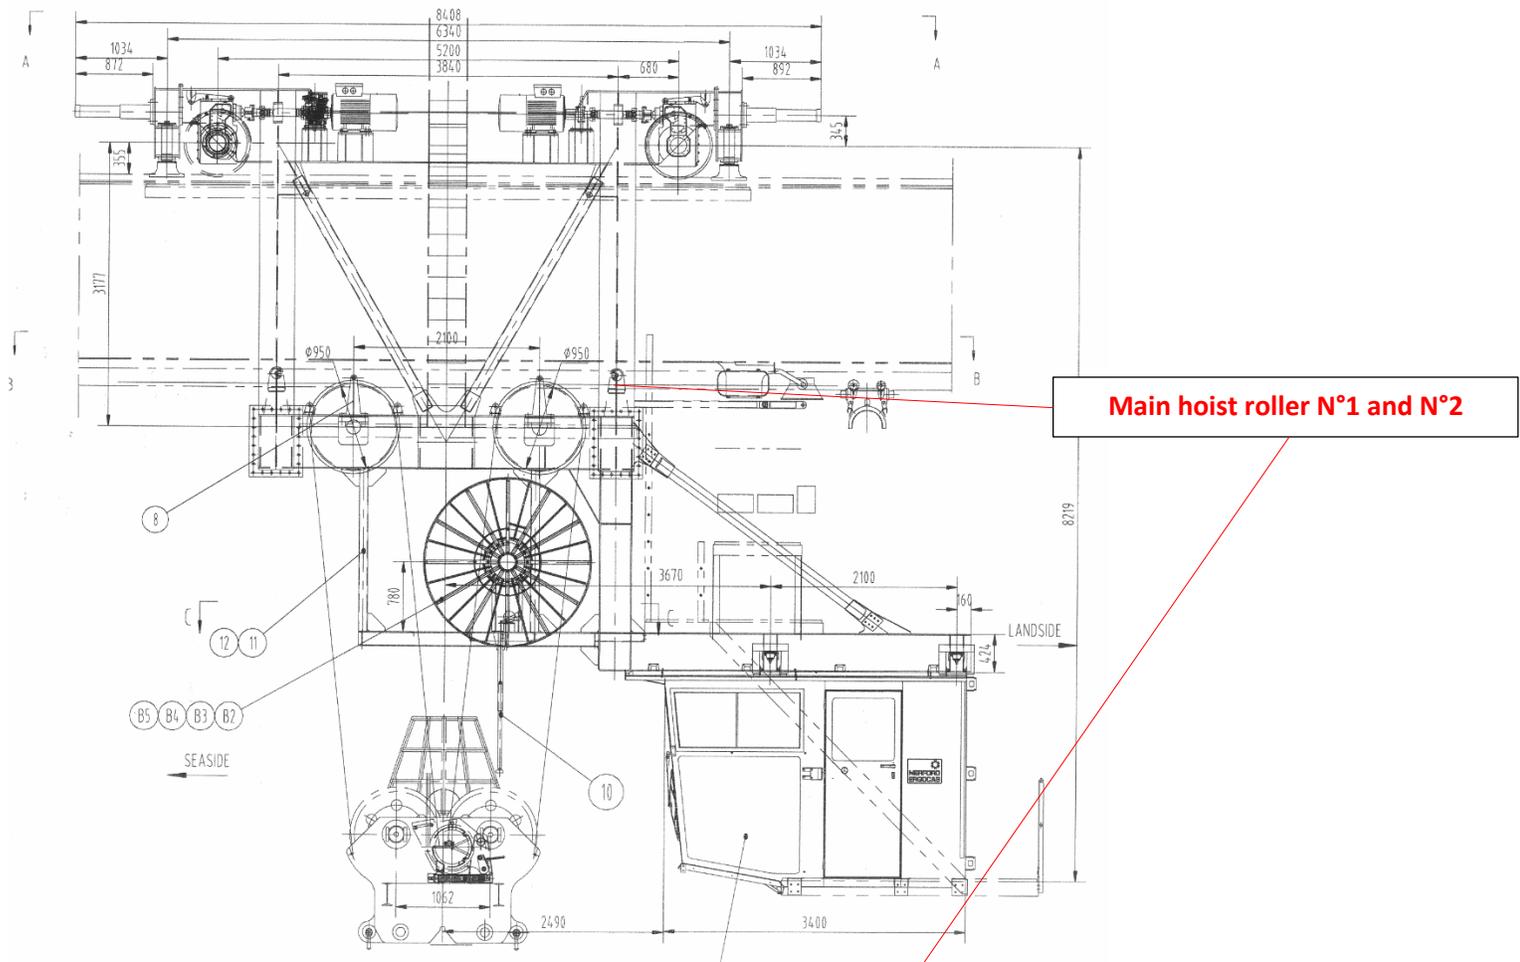
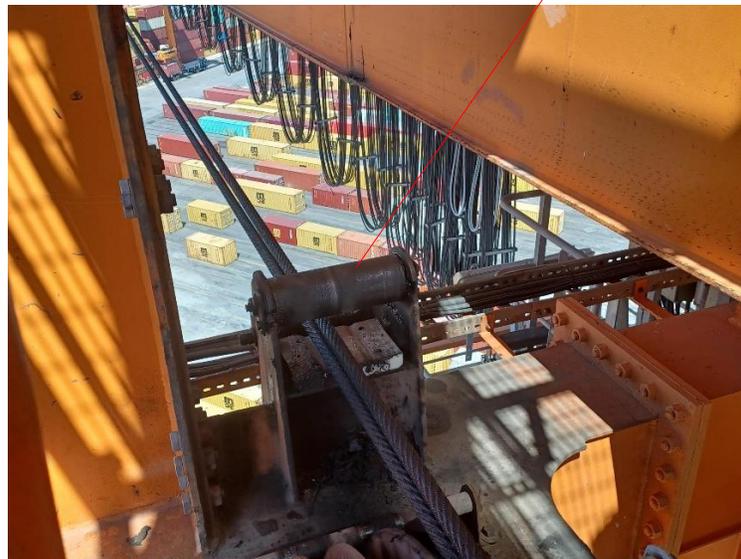
Main Hoist roller N°1 & N°2 due to wire rope wears very quickly, a modification is required.

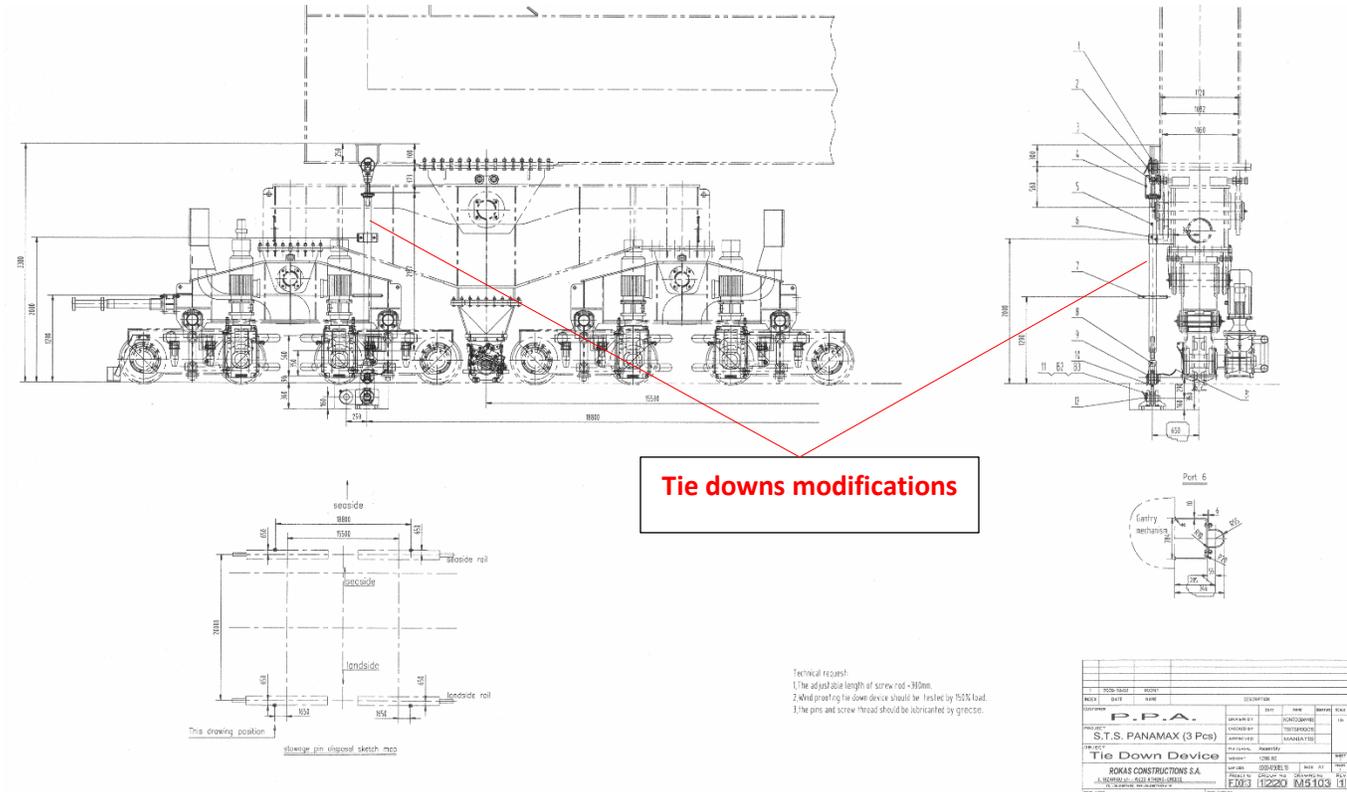
The four existing tie downs the “Tie down” should be replaced by wire ropes.

- At the portal beam (right side) handrails should be installed for safety reasons, please refer to chapter 3.8.
- The four existing tie downs the “Tie rails” should be replaced by wire ropes, please refer to chapter 3.9.
